The above location is a Power Plant in southern California. It has yet to be determined what additional damage has occurred since this fault happened only a few days ago on March 23rd 2002.

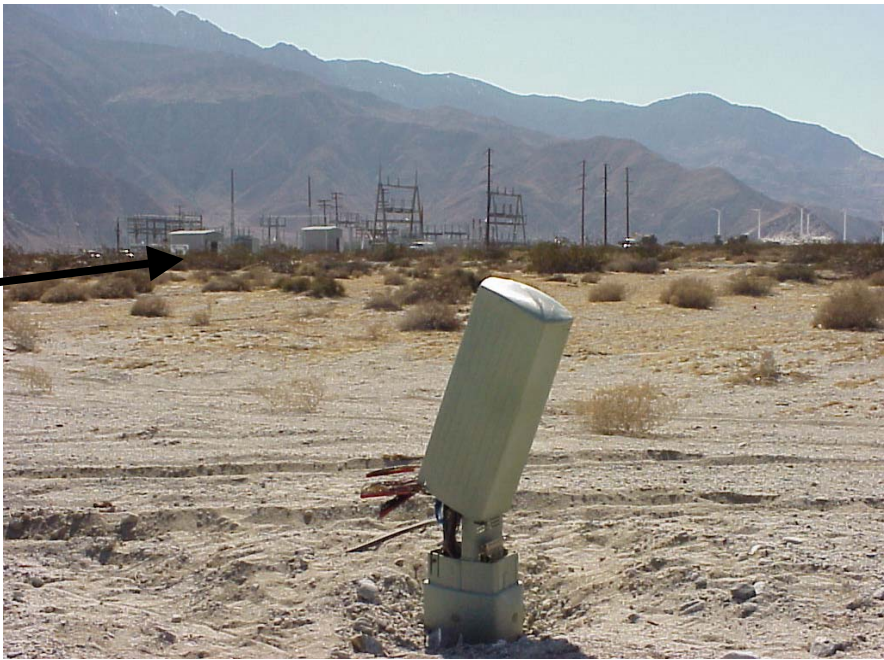
Telco pedestal approximately 800 feet away from Sub Station shows destroyed copper Telco pairs and splice connections.

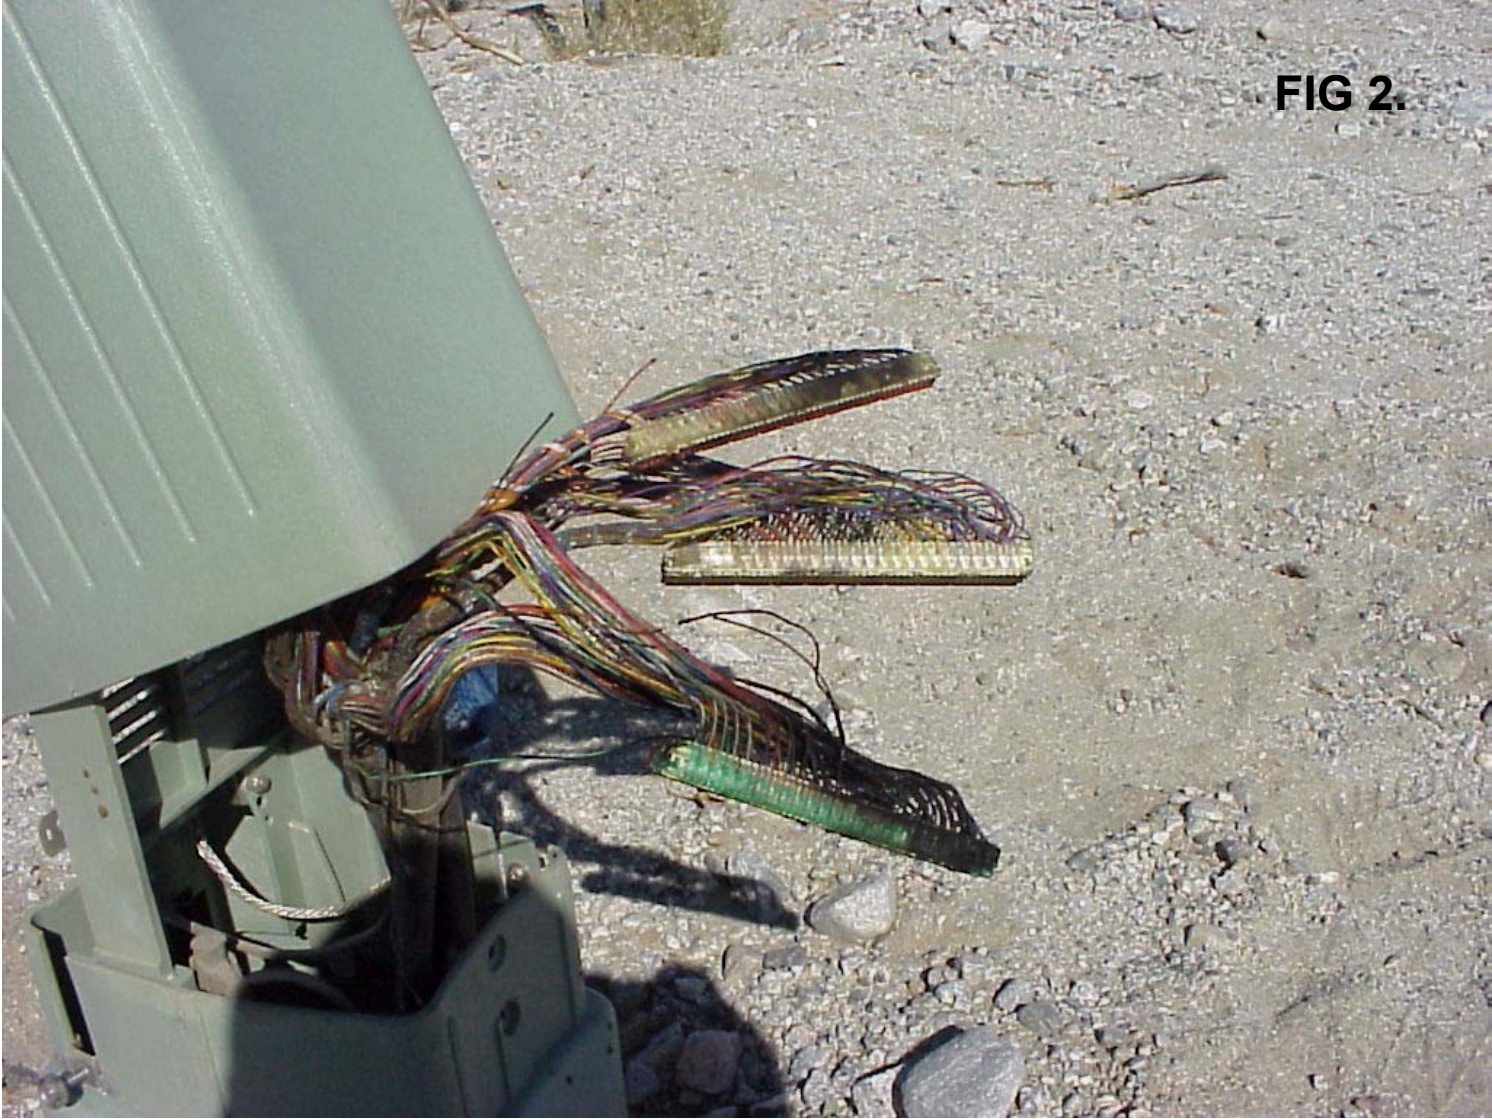
Sub Station
shown in
background

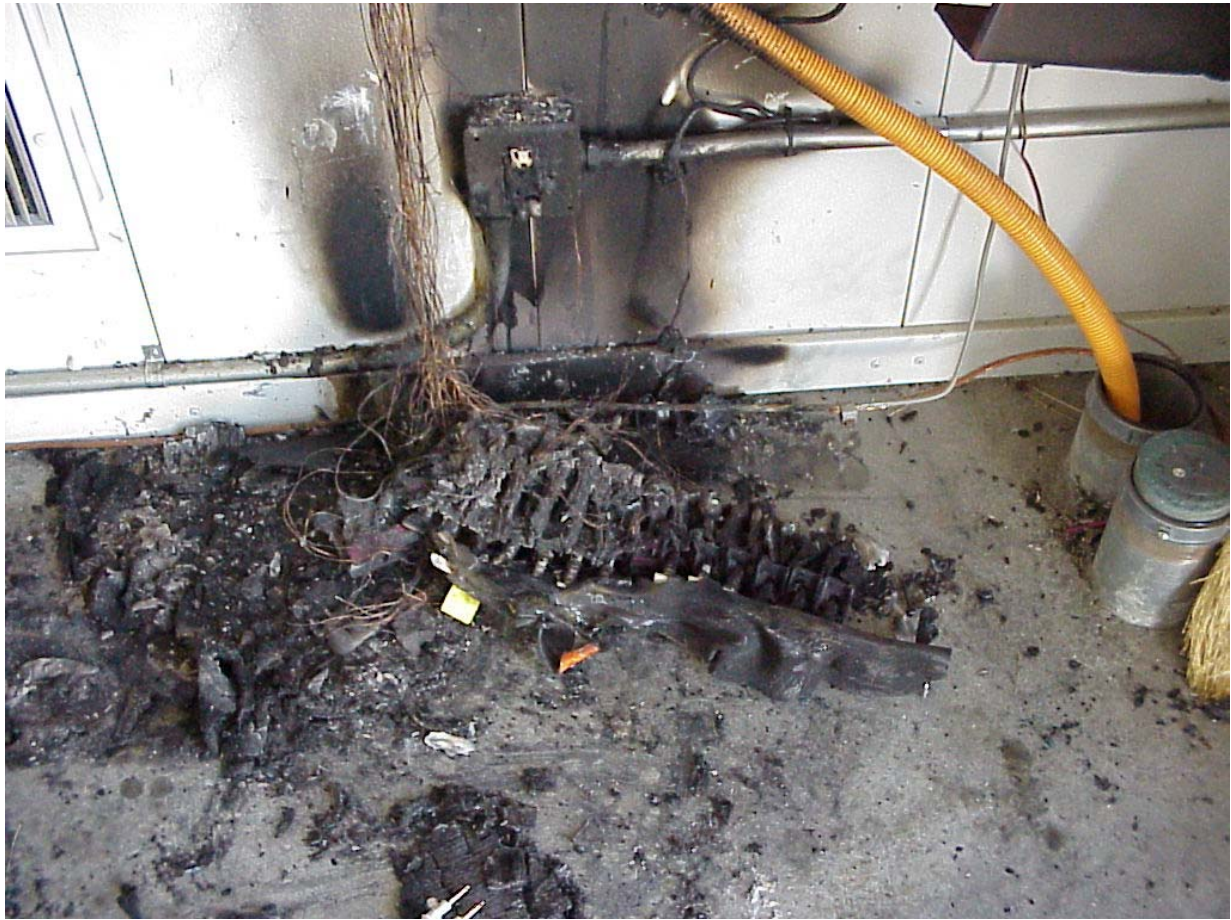
Remains of protector block on the floor above along with burnt and miscellaneous component pieces.

The fiber optic link will now be installed at this location.
